Inspection and Maintenance Manual

FRP Composite Structures

March 30, 2021

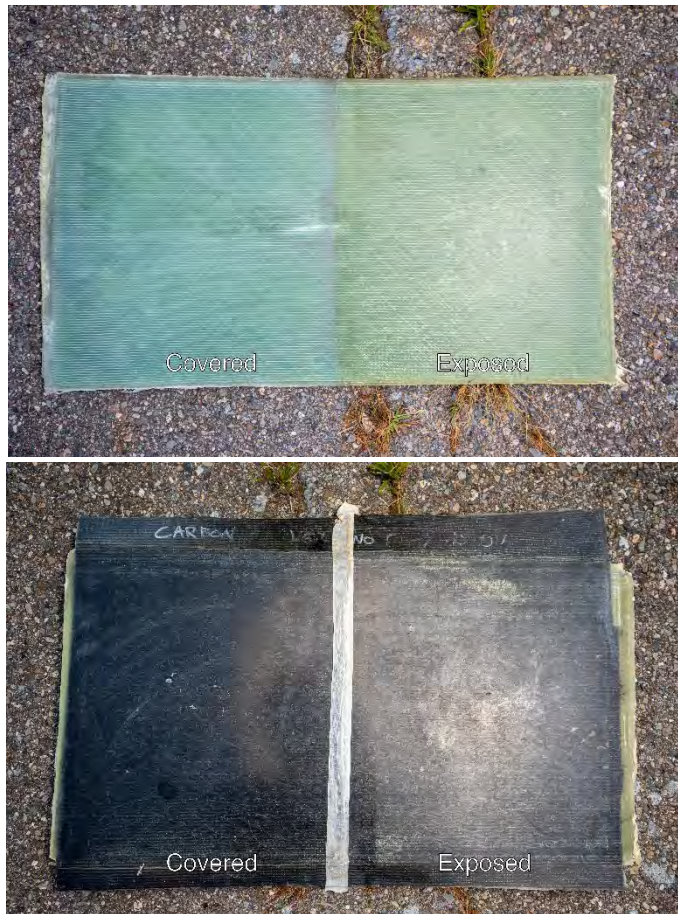
Discoloration and fading are not structural issues on their own, but they can be indicators that there is potential damage. Some early GArch bridges utilized a sacrificial veil layer known as bleeder cloth which provides a resin-rich surface that protects the reinforcing fibers below. A number of projects have also utilized a UV-resistant paint or resin pigment; however, UV exposure may still cause color fading. Discoloration can indicate abrasion damage, which if significant could be cause for maintenance or repair.

Figure 19: Example of Fading and Discoloration after UV Exposure

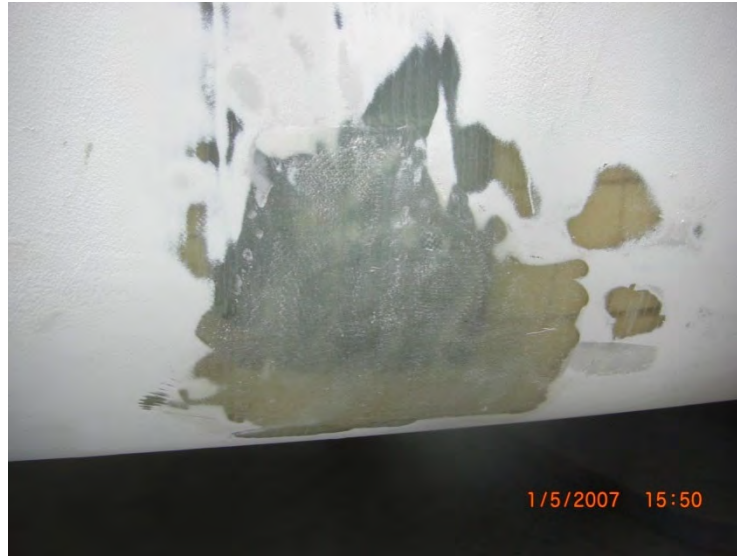
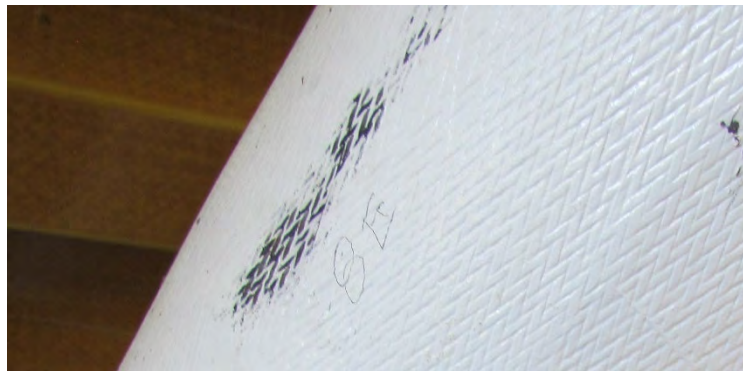
Typically, abrasion or fiber exposure is a result of improper handling or storage of materials prior to installation. Abrasion damage can be the result of exposure to water or other non-aggressive, but persistent physical contact. Abrasion that affects only the protective resin coat with no exposure of fibers is non-structural and can be repaired by recoating with a UV-resistant resin coat. If the source of abrasion is identified and cannot be avoided the composite should be coated with a resin with abrasion resistant fillers. A reinforcement or additional veil layer may be added for additional protection. If exposed fibers are left untreated, they can form into cracks or delamination over time with exposure to freeze-thaw cycles or moisture absorption. A simple repair of recoating the fibers with resin should alleviate future concerns.

Figure 20: Examples of Fiber Exposure or Abrasion

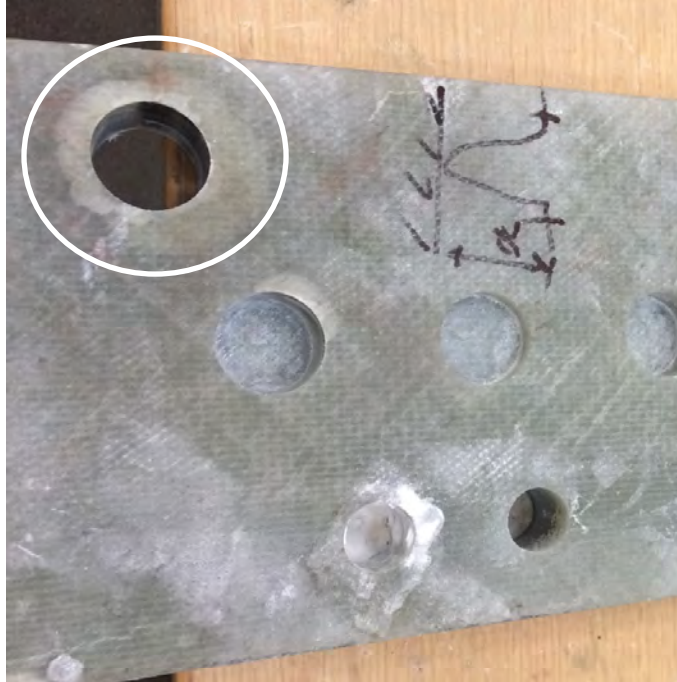
These can be small single layer external blemishes caused by high impact small projectiles or hand tools or larger area encompassing deeper multi-layer separations caused by higher momentum carry loads (e.g. over height loads carried by over the road trucking and freight carriers). Classifying these types of material defects can be done by visual inspection augmented with auditory tap testing. Delamination can be a result of an internal void space continuing to expand and may be difficult to see as it may not always migrate to the surface. Auditory tap testing can quickly determine if a void or delamination is present beneath the surface, but the extent of depth may require the use of ultrasonic technology, infrared thermography, or ground penetrating radar. Signal penetrating equipment and technologies such as these typically require special training that is material specific.

Figure 21: Example of Delamination around a Drilled Hole

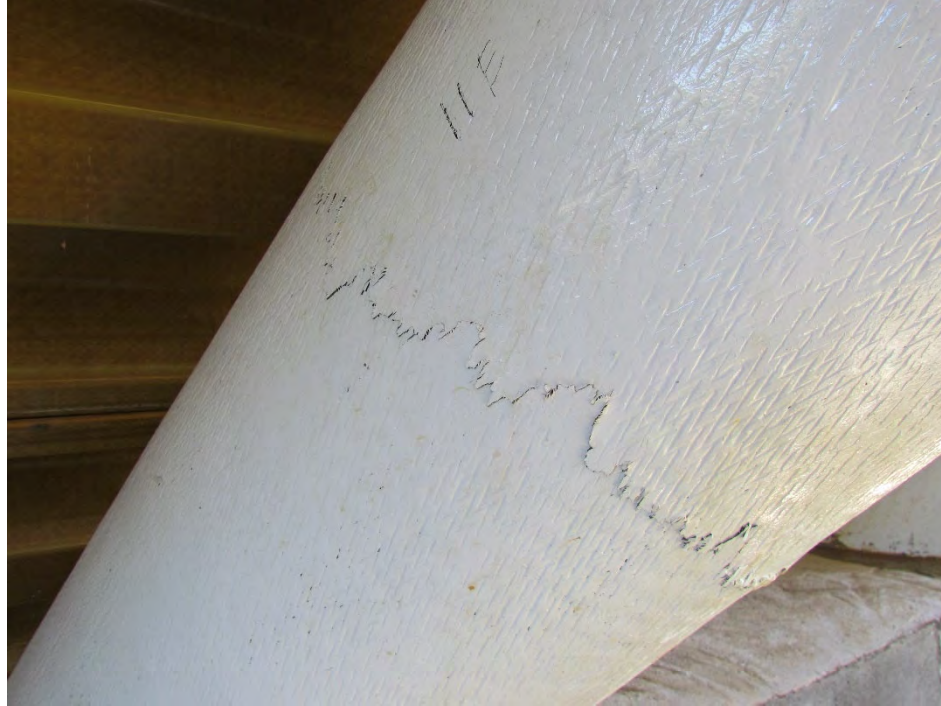
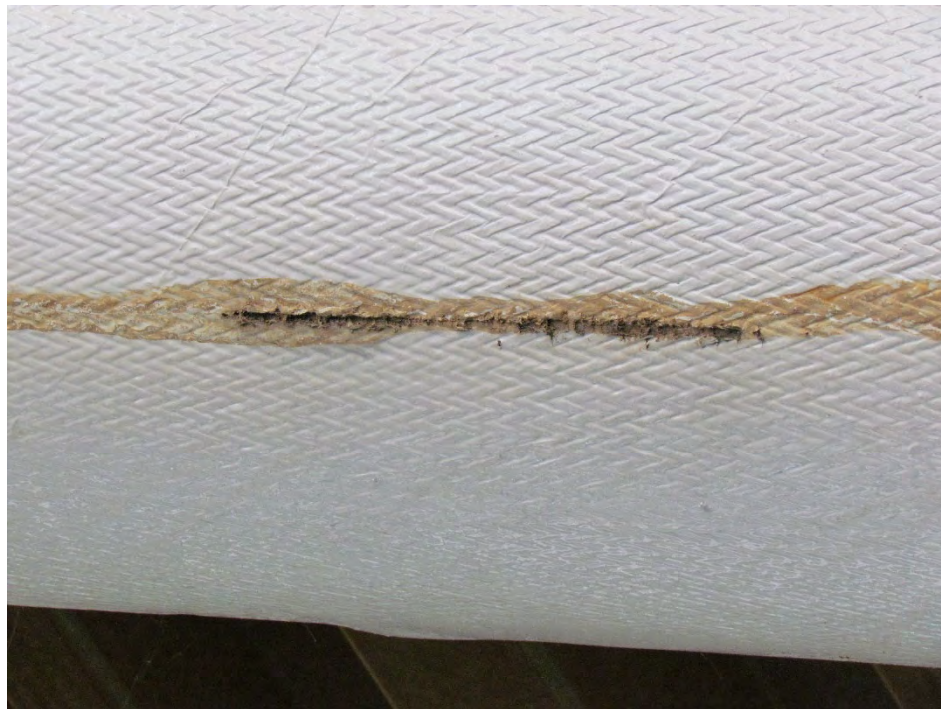
Scratches can occur from multiple sources such as high velocity water flow carrying floating or suspended debris such as tree branches or ice, improper material handling or storage, improper construction sequence leading to overstress, or non-natural causes like vandalism. Subsurface scratch damage differs from abrasion and fiber exposure in that the fibers are typically damaged.

Figure 22: Examples of Subsurface Scratching

Any damage to the fibers represents structural damage. Since composites are a mixture of many fibers and a matrix binder, oftentimes minor scratches are simply repaired by recoating with resin. Any damage larger than one square inch in size should be inspected closely to determine the extent of damage. Damage affecting a significant amount of the fibers should be repaired with additional fiber reinforcement using industry standards with materials equal to or better than the fibers that have been damaged. The repair method will depend on the severity and extent of damage to the fibers, but all work performed should be done by a Certified Composites Technician.

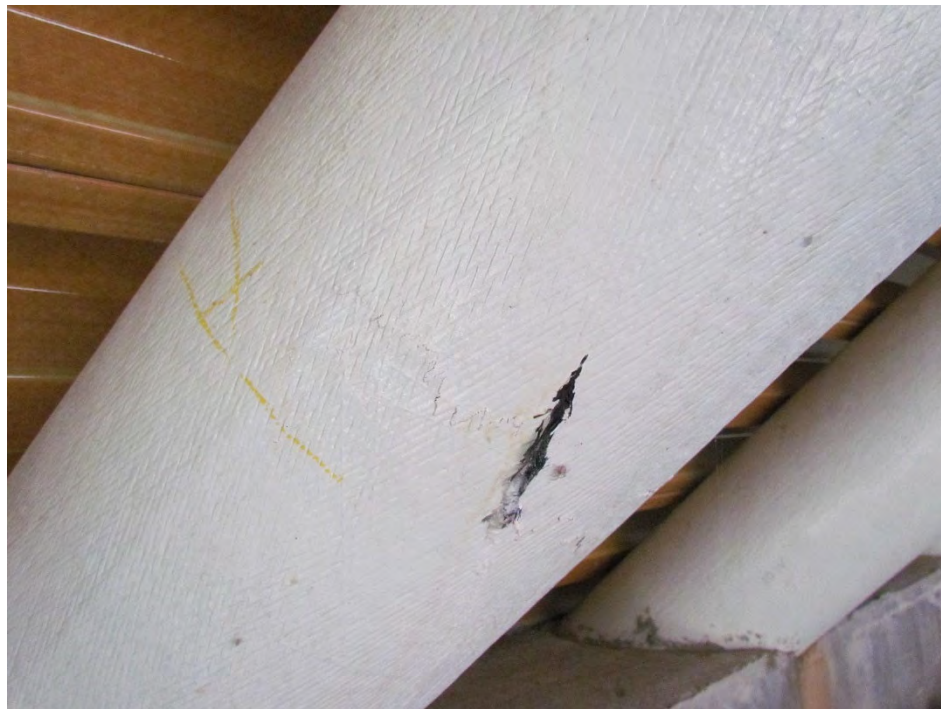
Large laminate penetrations and gouges that extend through the thickness of the laminate represent severe damage and should be repaired immediately by a Certified Composite Technician. Any penetration through the entire laminate larger than 1" in square should be

Figure 23: Example of Laminate Penetration

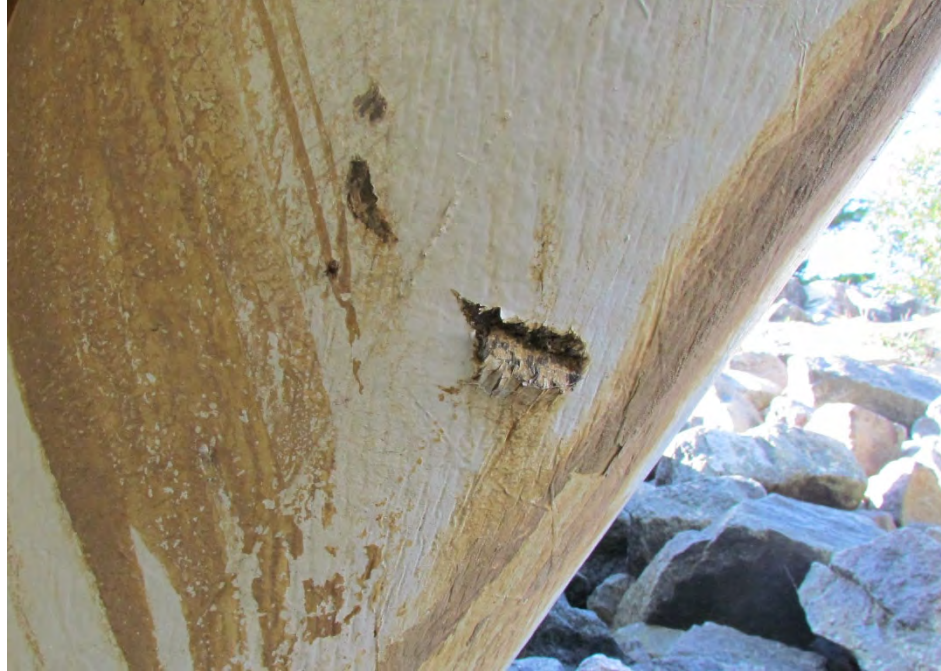
Figure 24: Example of Laminate Gouging

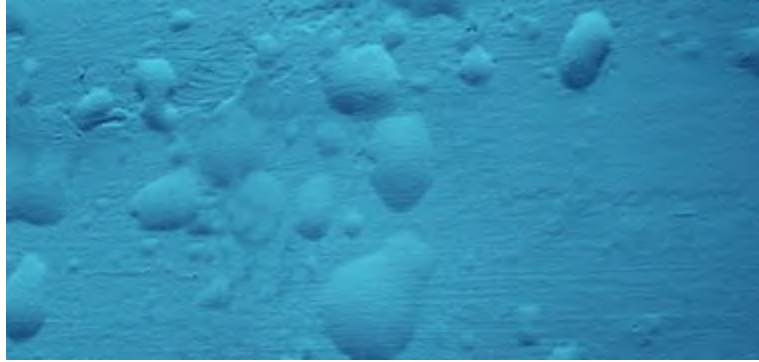
Blistering or bulging is common in FRP members that utilize a gelcoat or painted surface finish. Blistering occurs when moisture gets trapped between the laminate and the surface coating. These blisters are not likely to cause structural concerns but are potential sources for future issues if the bridge member is located in an environment that experiences freeze-thaw cycles. Blisters should be removed and sanded flush with the surrounding area and recoated with a surface coat of resin or paint.

Figure 25: Example of Blistering or Bulging

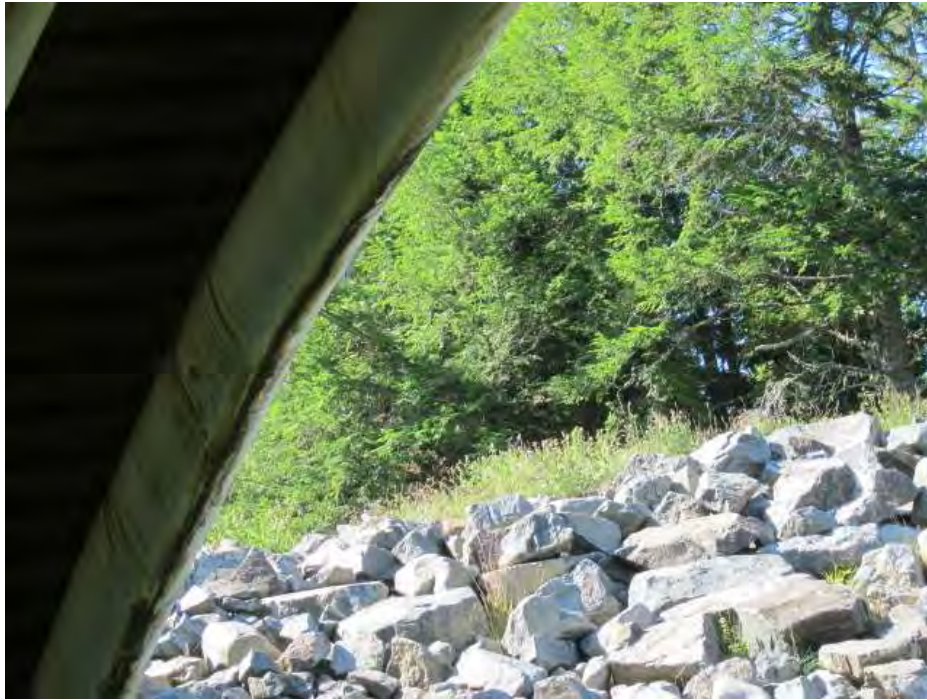
PHOTO 8

Description West Composite Tube - Staining on bottom

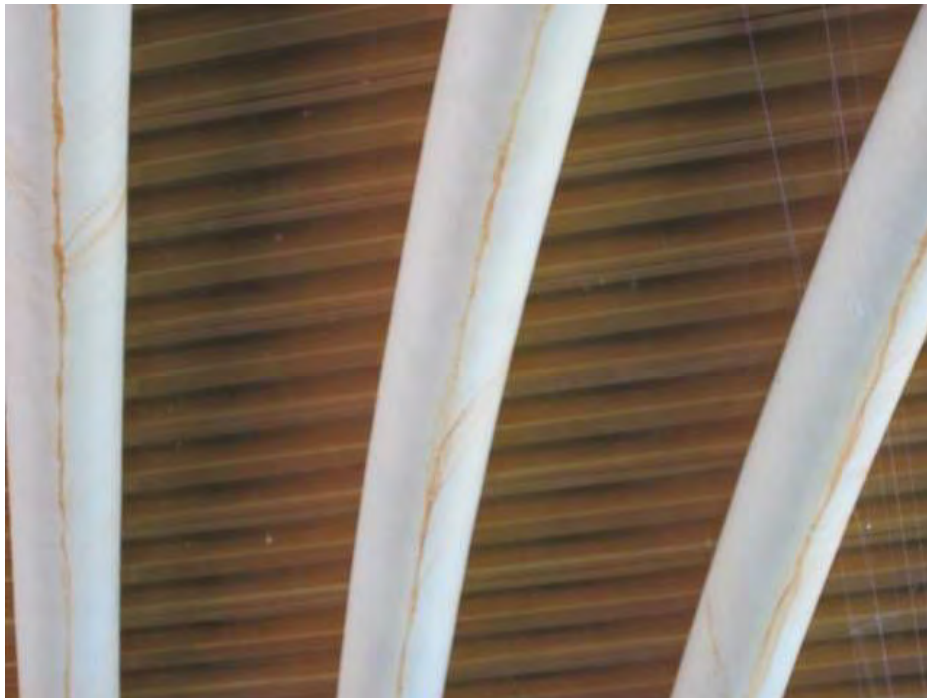
PHOTO 9

Description Interior tubes - Staining at bottom

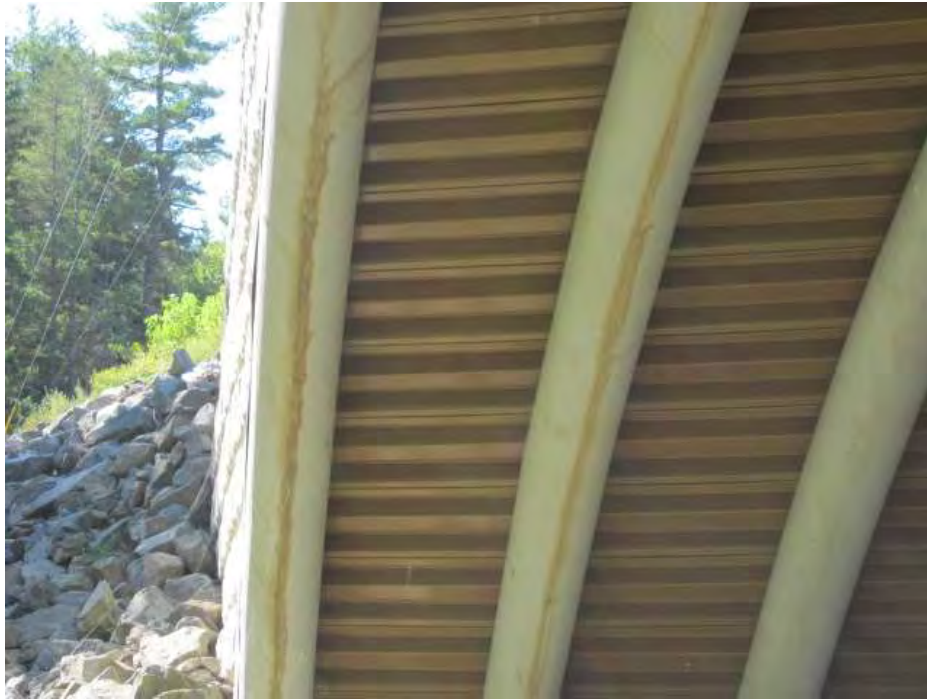
PHOTO 10

Description Staining of East Tube

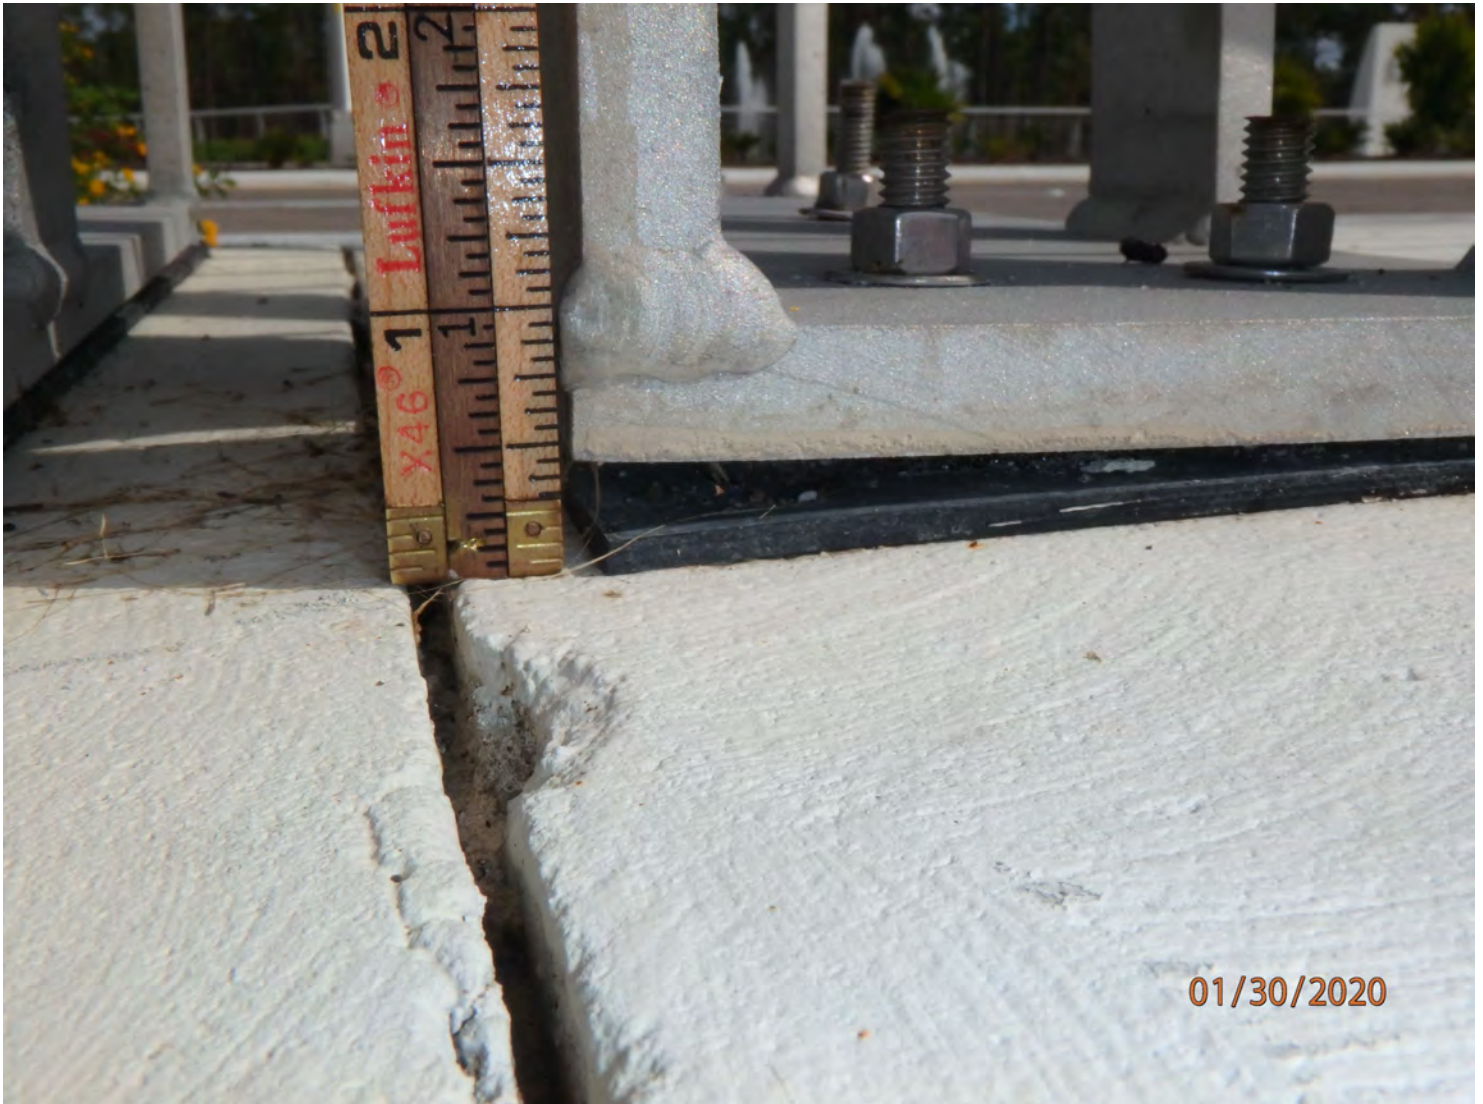
Photo 1 - Element 333/3 Other Bridge Railing

Gap in left approach sidewalk hand rail baseplate. Typical.

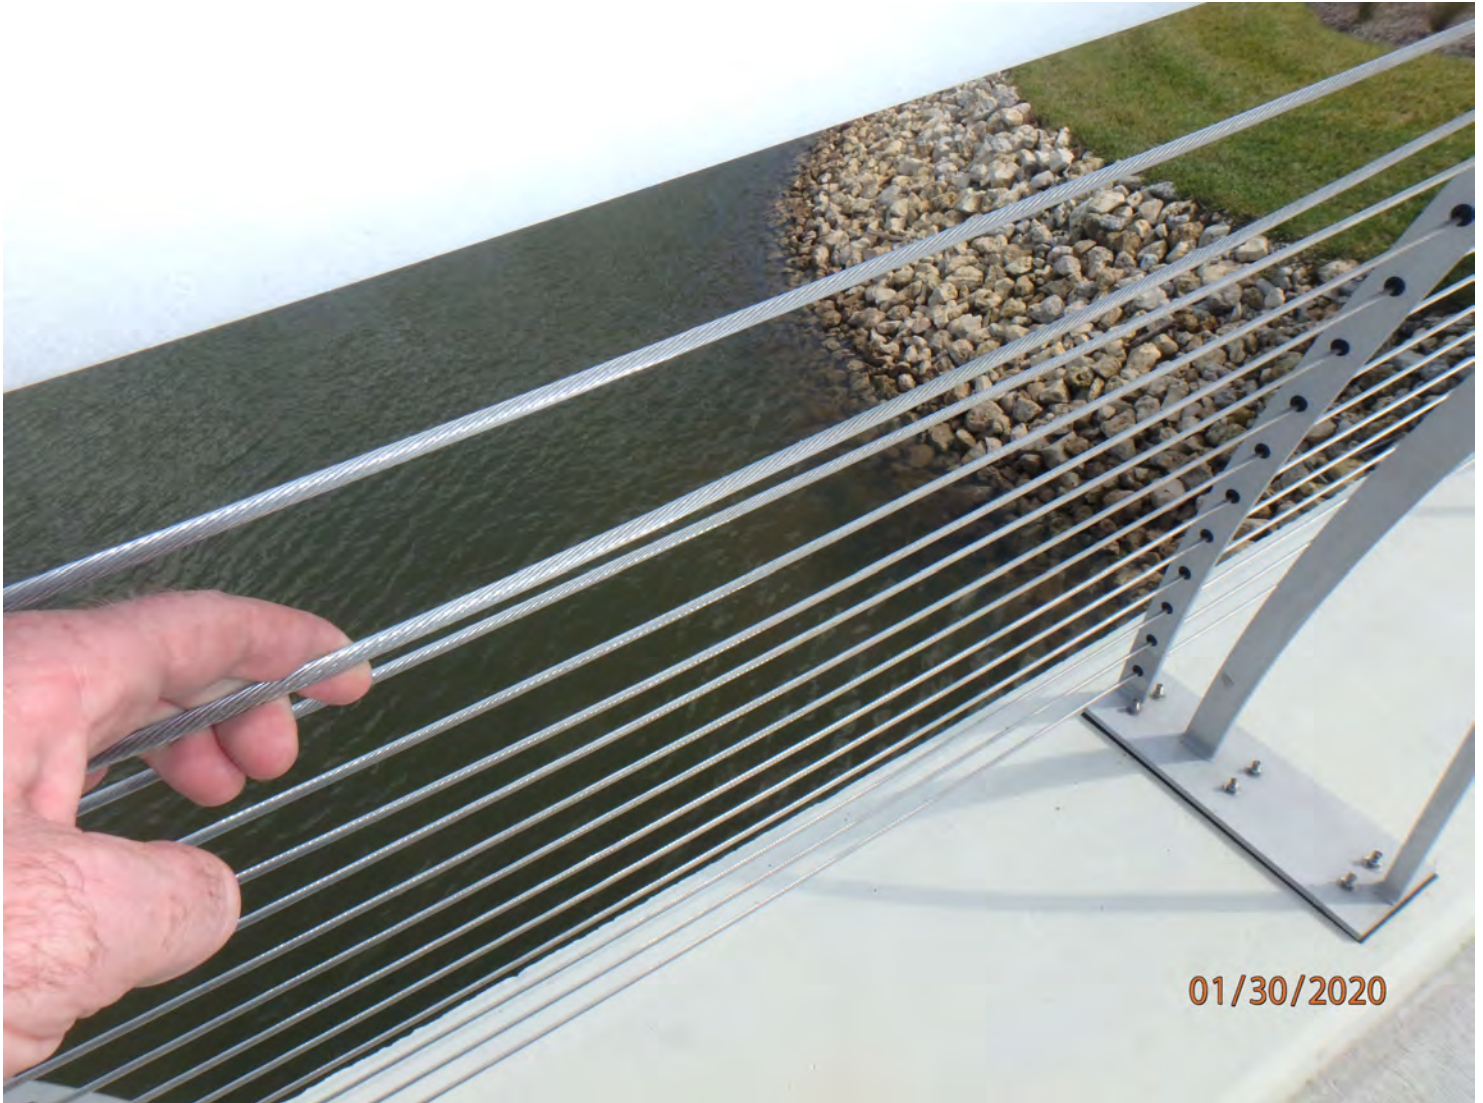
Photo 2 - Element 333/3 Other Bridge Railing

Slack in 2nd hand rail cable from top for the right hand rail over arch.

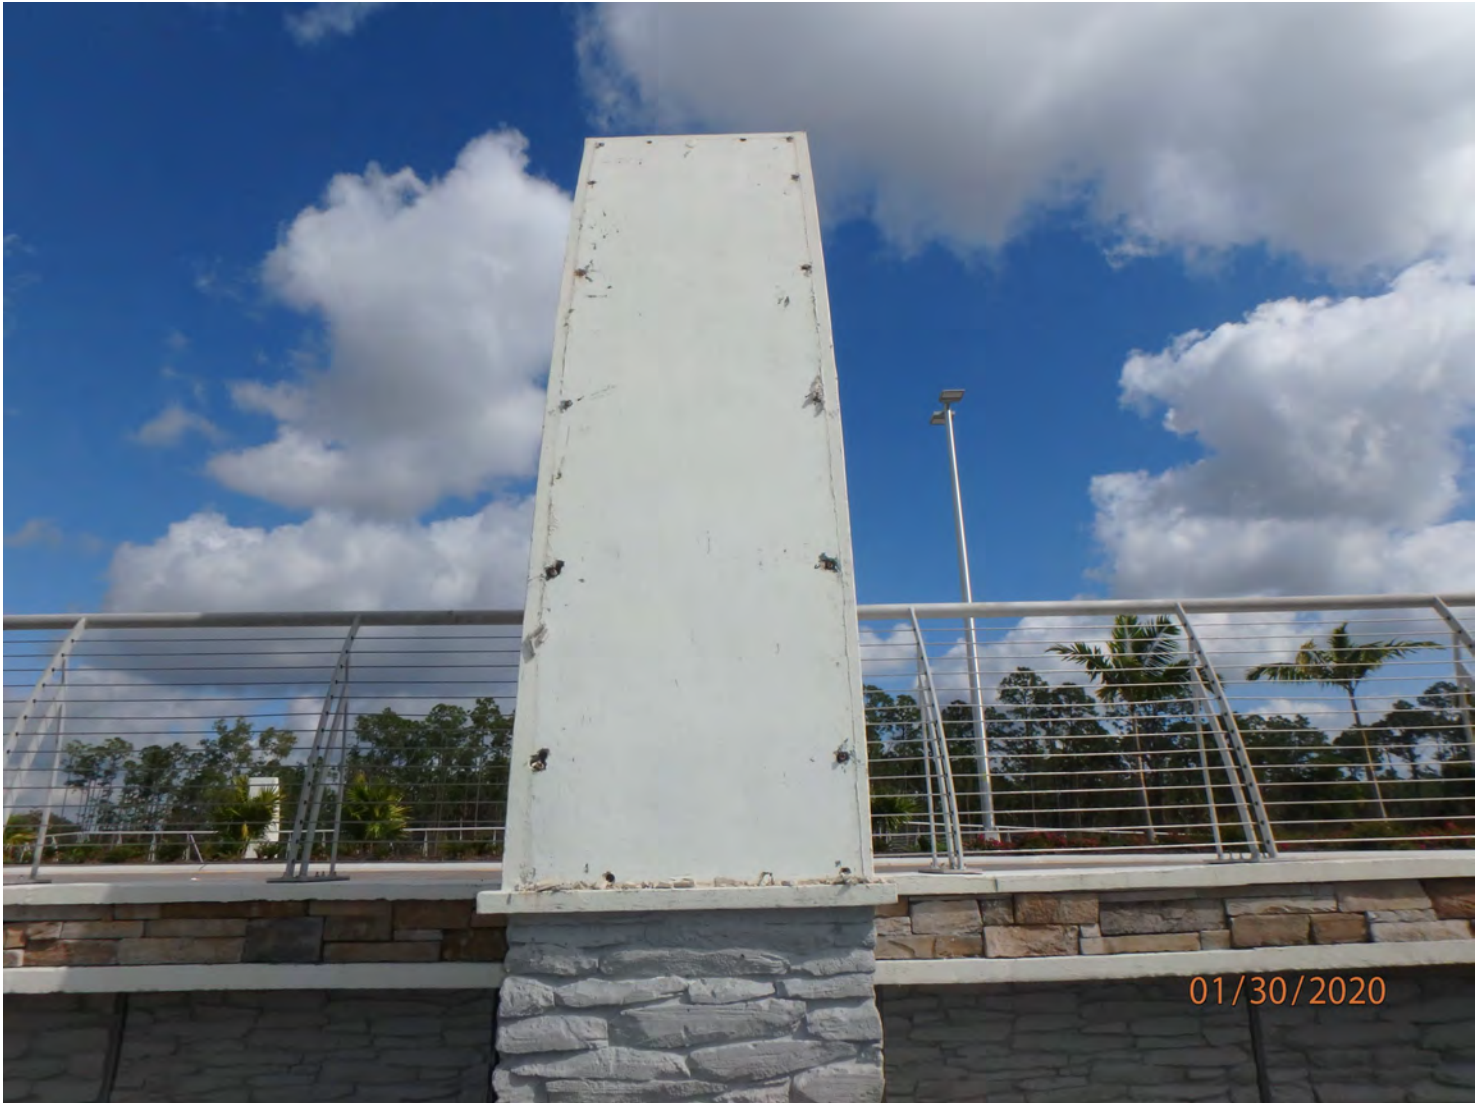
Photo 3 - Inspection Notes

Protruding bolts at northeast pillar. Typical.

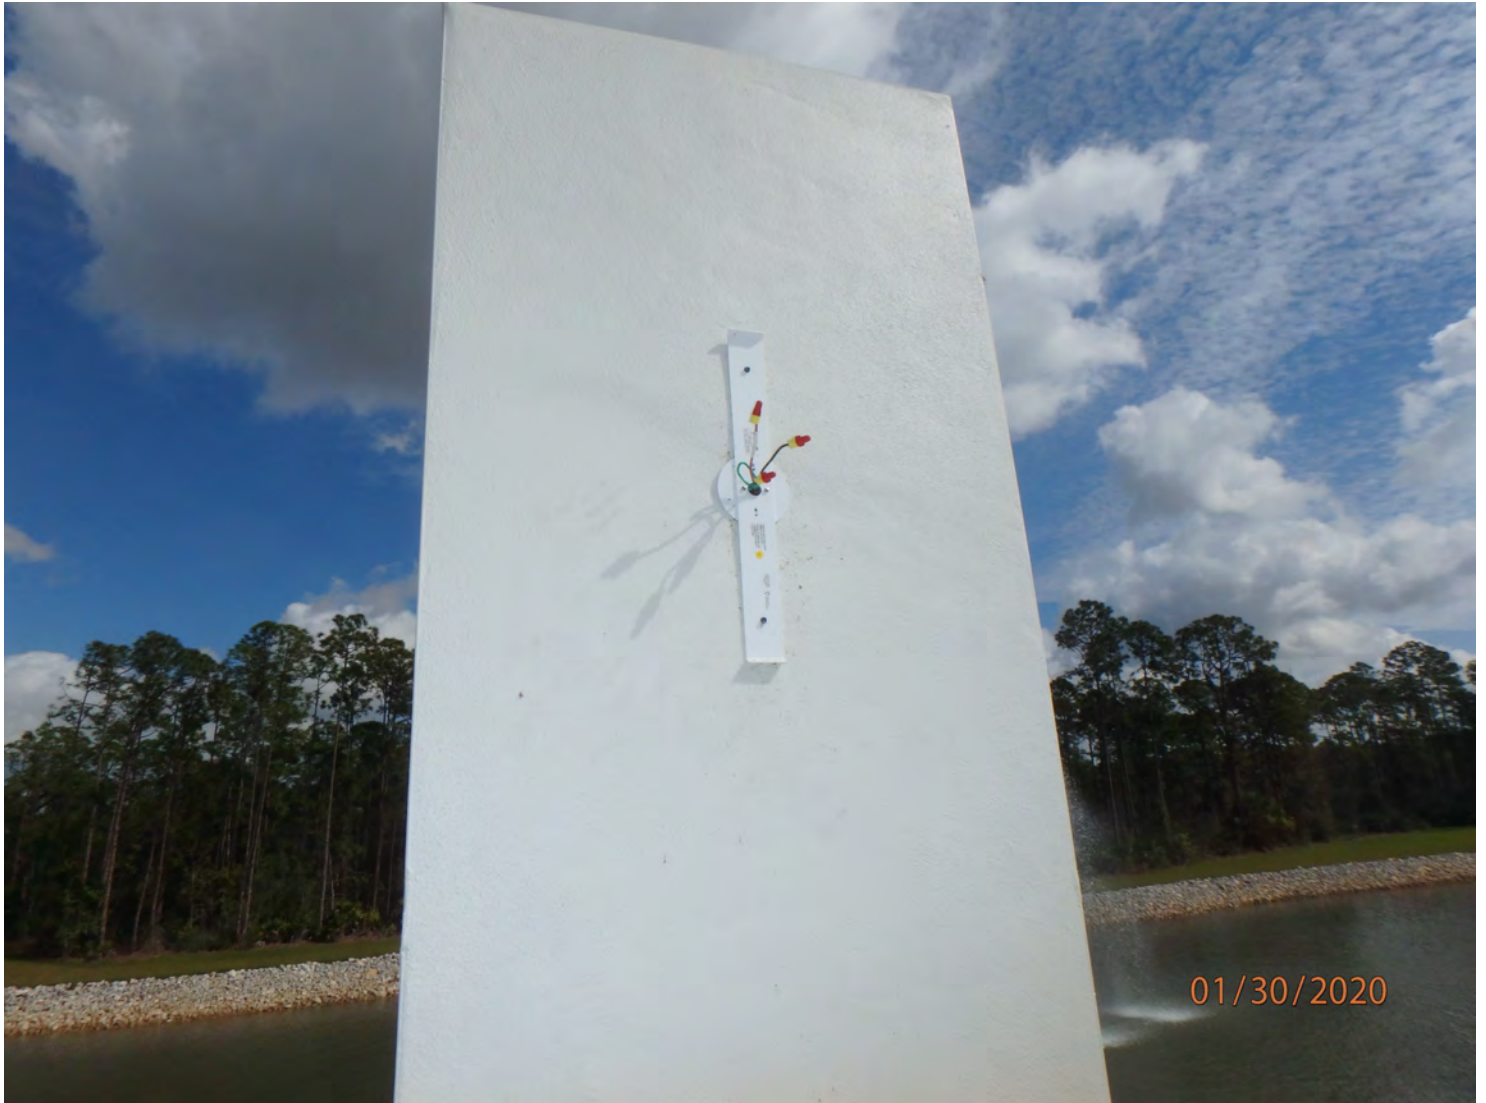
Photo 4 - Inspection Notes

Missing light fixture with exposed wires at northeast pillar.

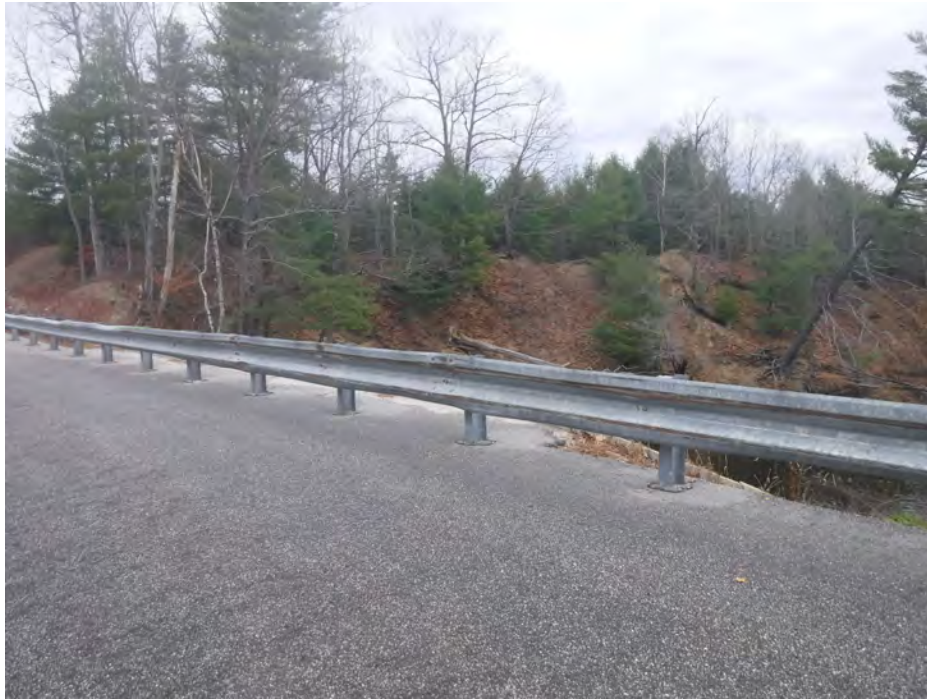
PHOTO 3

Description Guardrail damage

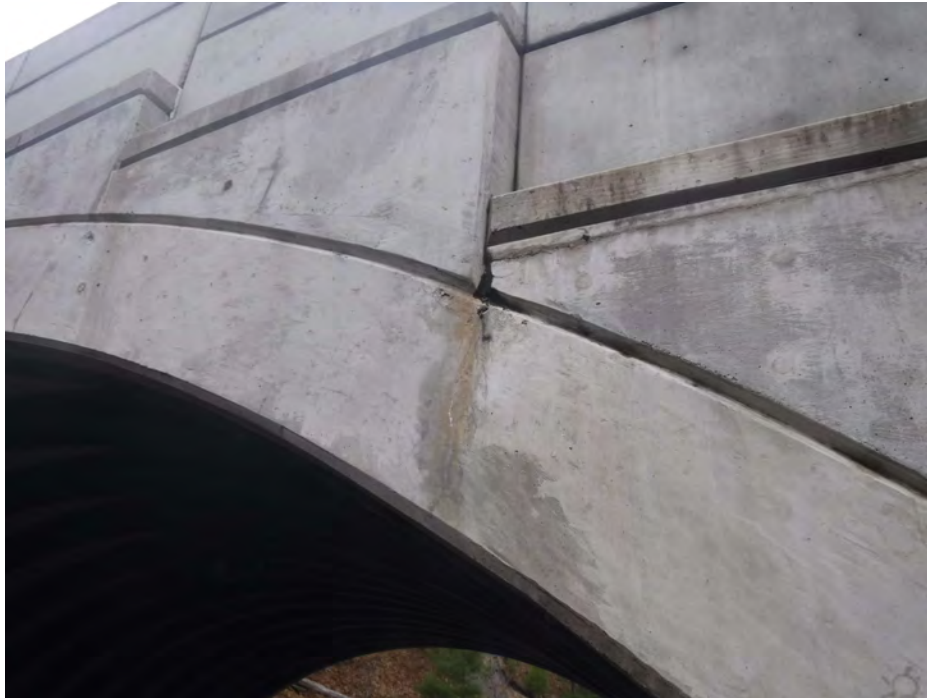
PHOTO 9

Description Small cracks in concrete arch fascia
