Inspection and Maintenance Manual

FRP Composite Structures

March 30, 2021

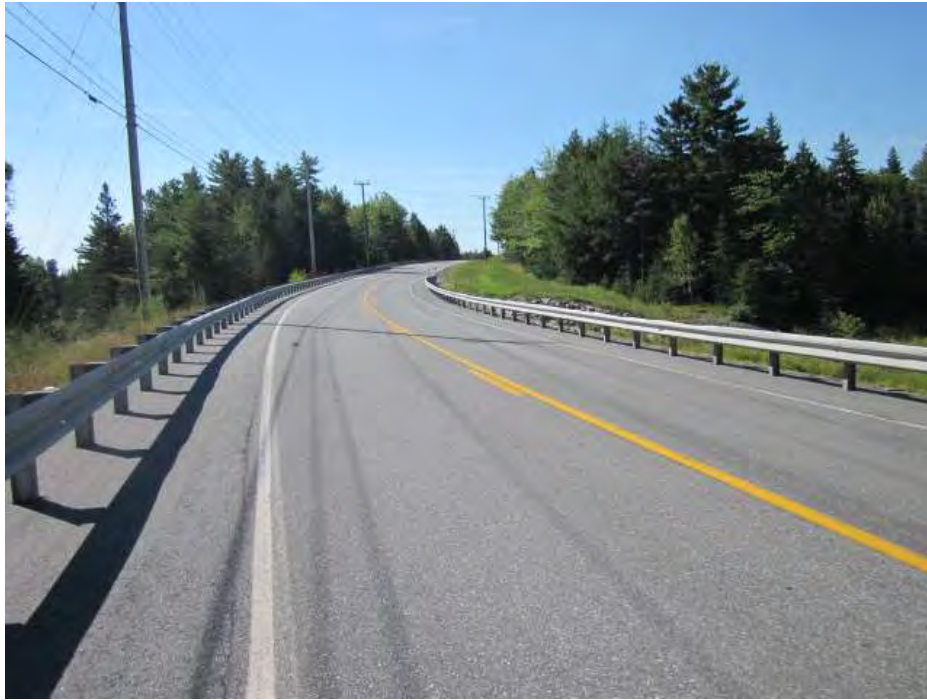
PHOTO 1

Description Roadway looking South

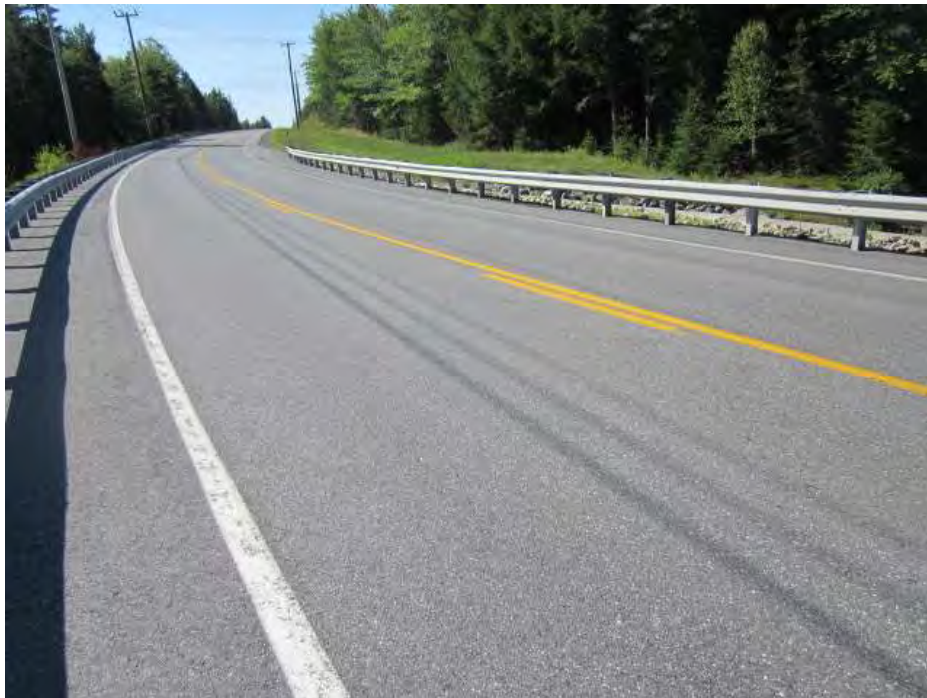
PHOTO 2

Description Roadway pavement above Bridge

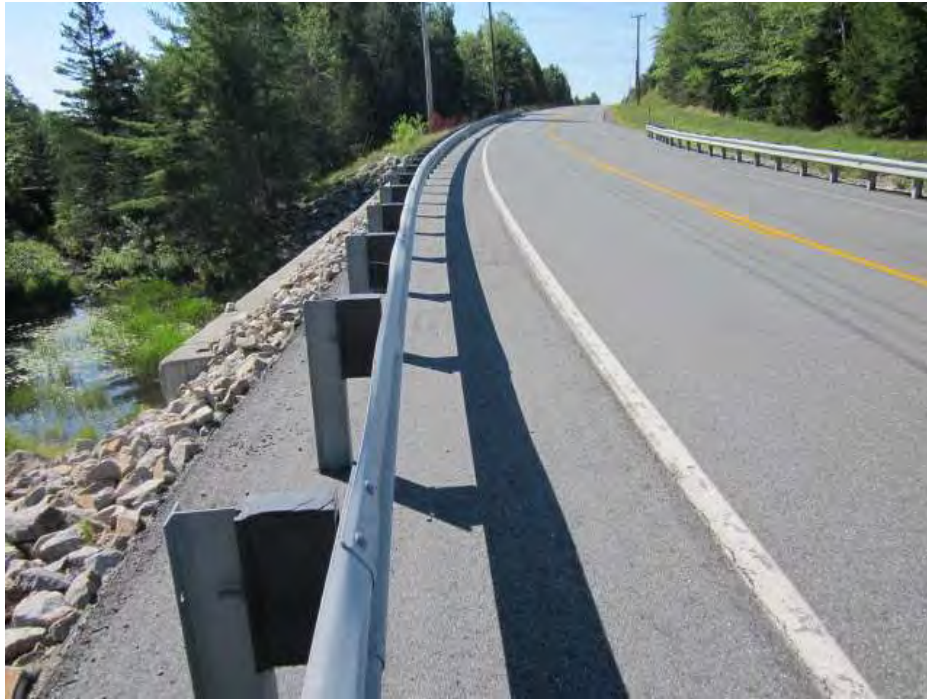
PHOTO 3

Description Guard Rail View

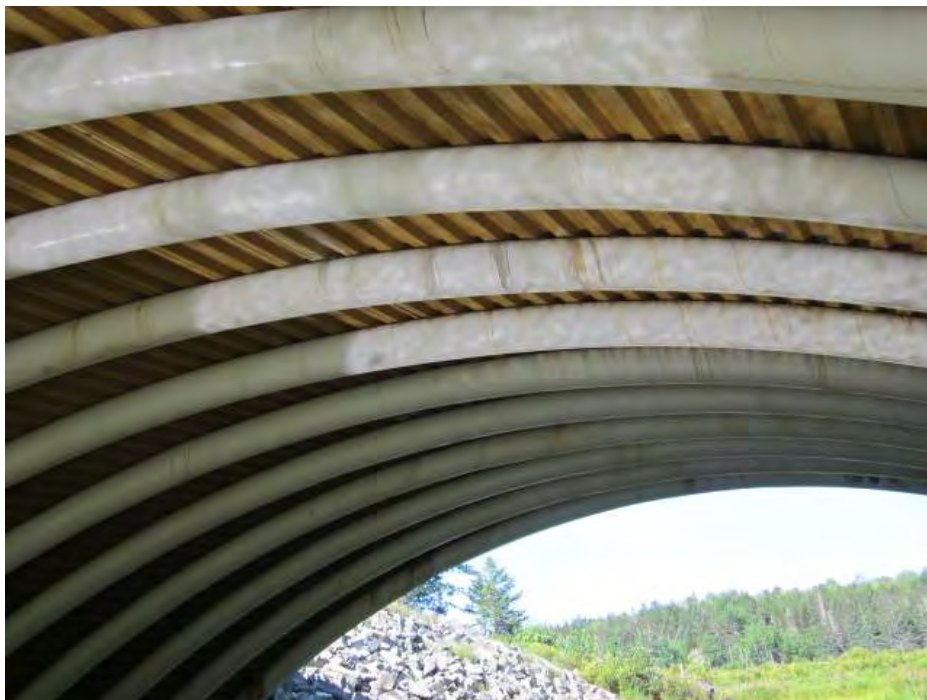
PHOTO 5

Description Barrel View looking West

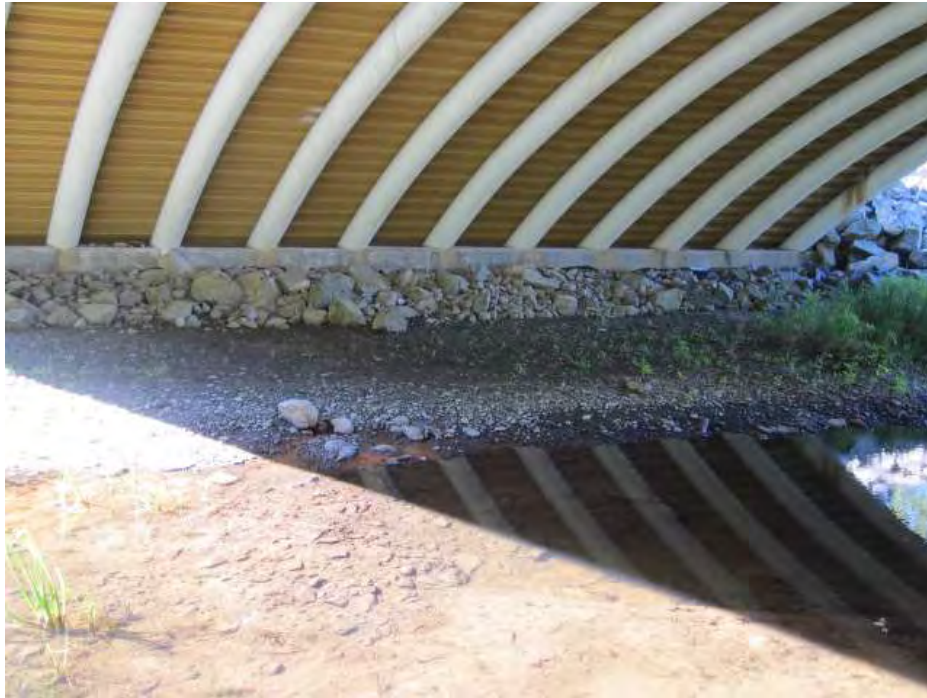
PHOTO 6

Description South Footing View

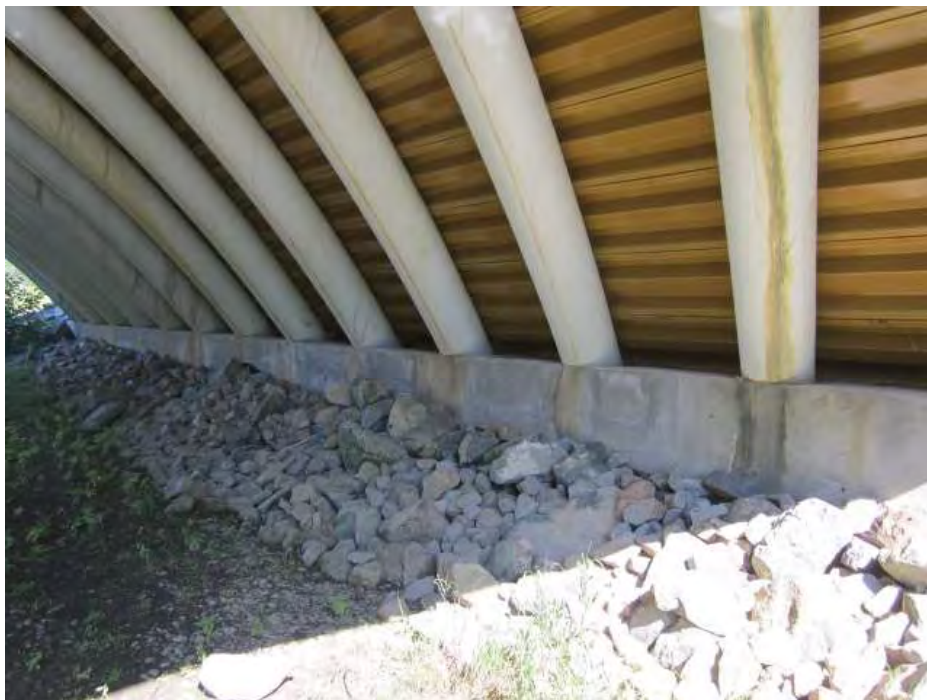
PHOTO 7

Description North Footing View

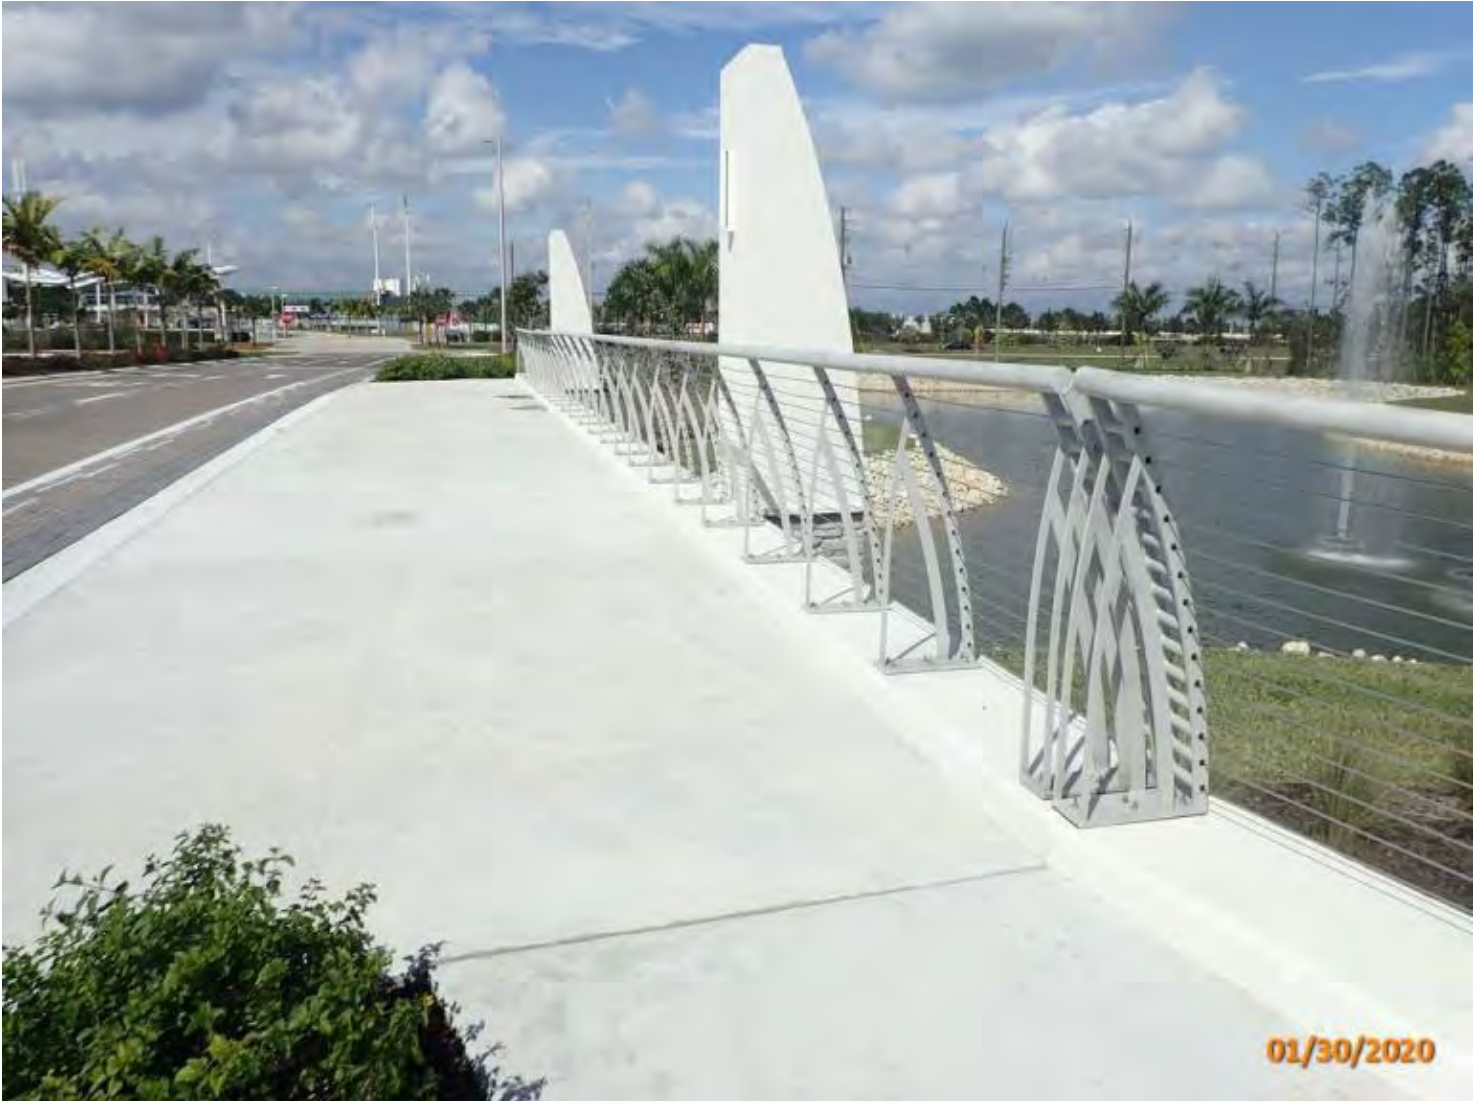
SIDEWALK HANDRAIL

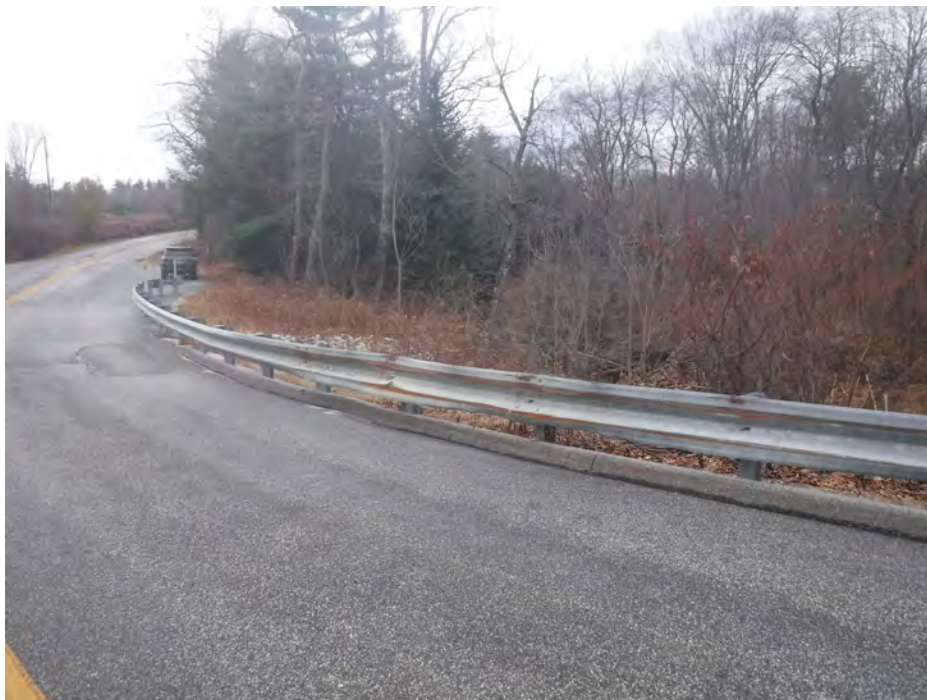
PHOTO 4

Description Guardrail damage upstream rail

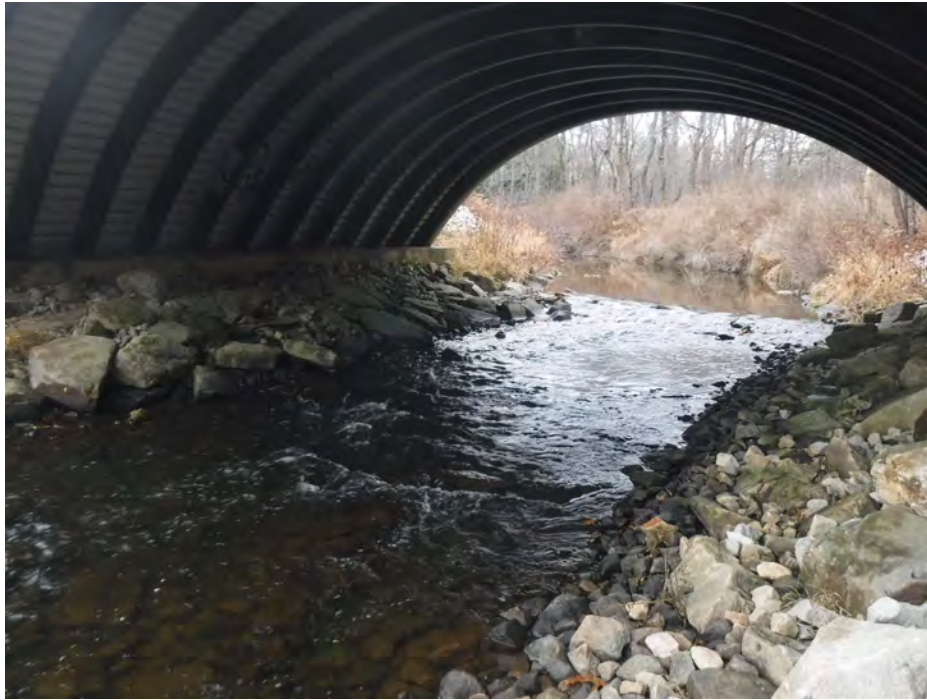
PHOTO 7

Description Channel typical, well centered and protected

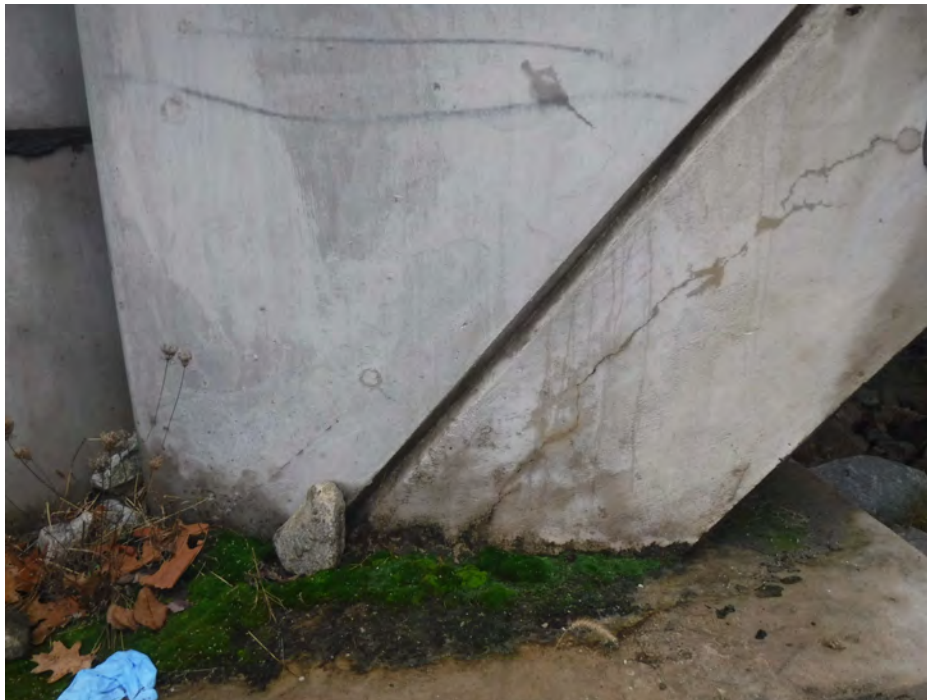
PHOTO 8

Culvert in very good condition with scattered minor cracking and efflo stains in footings , Arch fascia and cast in place portion of walls.

Description Small cracks in arch fascia concrete

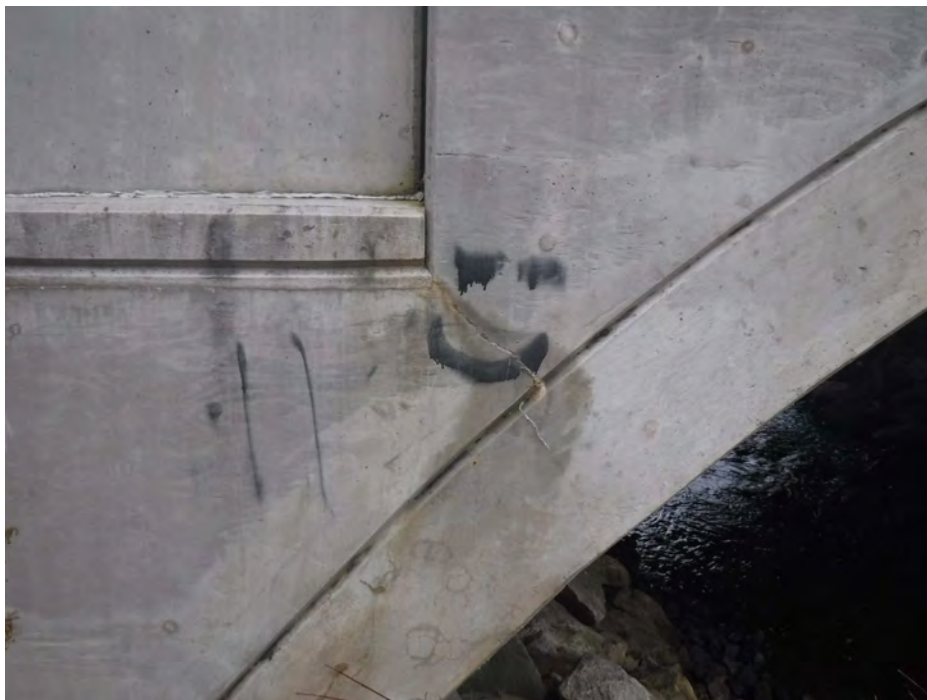
PHOTO 10

Description Small crack and leaking in arch fascia concrete
